INVESTIGATION OF HYDROTEST FAILURE
OF THIOKOL CHEMICAL CORPORATION
260-INCH-DIAMETER SL-1 MOTOR CASE

by John E. Srawley and Jack B. Esgar

Lewis Research Center

Start
The Thiokol Chemical Corporation 260-inch-diameter SL-1 ^A motor case failed during hydrotest at a pressure of 542 pounds per square inch, which was about 56 percent of proof pressure. The motor case was constructed of 250 grade ^{FEB} maraging steel plate joined mostly by submerged arc automatic welding. An investigation of the failure was conducted by a Committee composed of members from Industry and Government. Investigation showed that the failure originated from a defect that was not detected by nondestructive testing techniques prior to aging. Nondestructive testing was not conducted between aging and hydrotest. The defect causing the failure was in the heat-affected zone of a longitudinal submerged arc weld on the cylindrical section of the motor case. The area where the defect was located had been repaired by a manual gas-tungsten-arc (TIG) weld. The defect, which was submerged within the vessel wall and oriented longitudinally, was approximately 1.4 inches long and had a width of about 0.10 inch. Four other

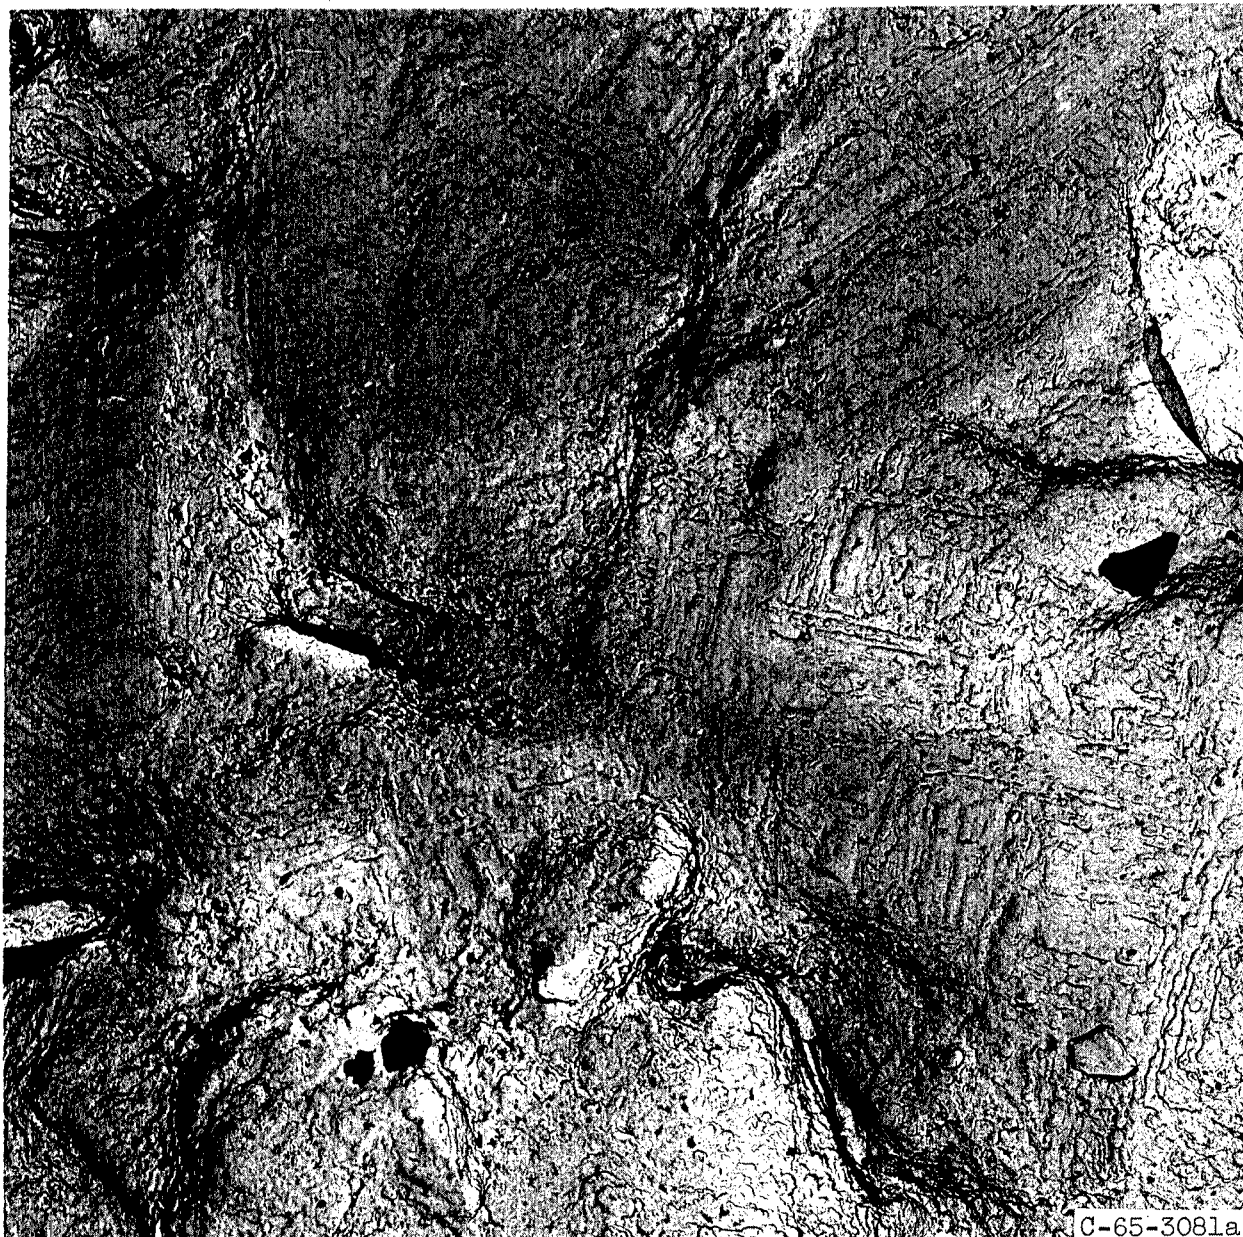
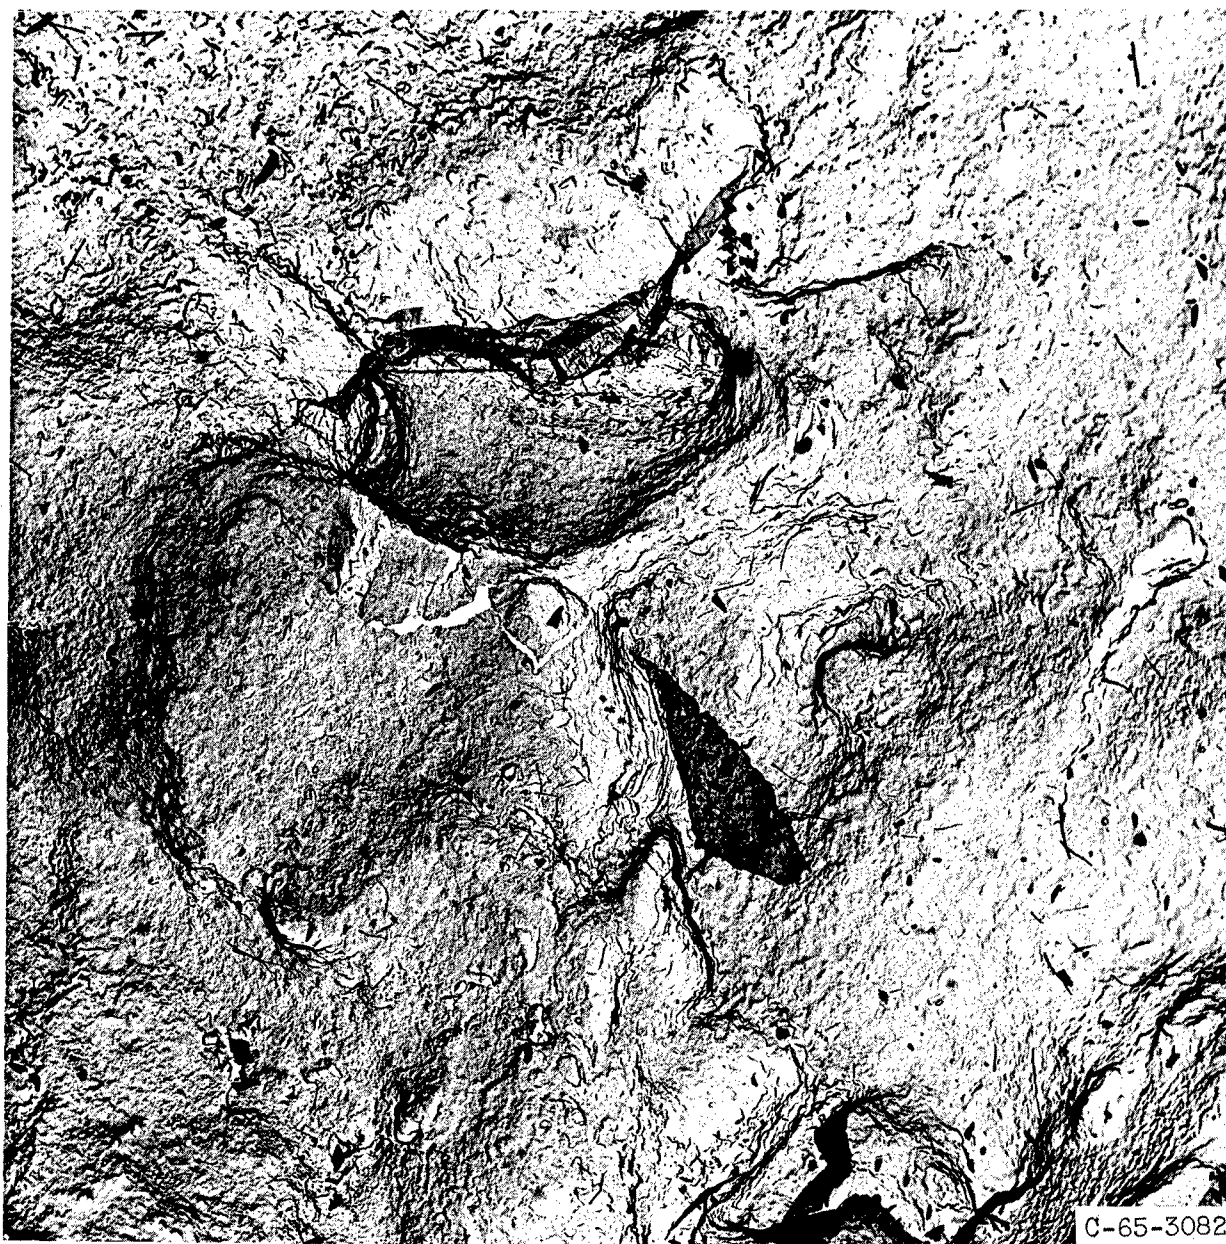
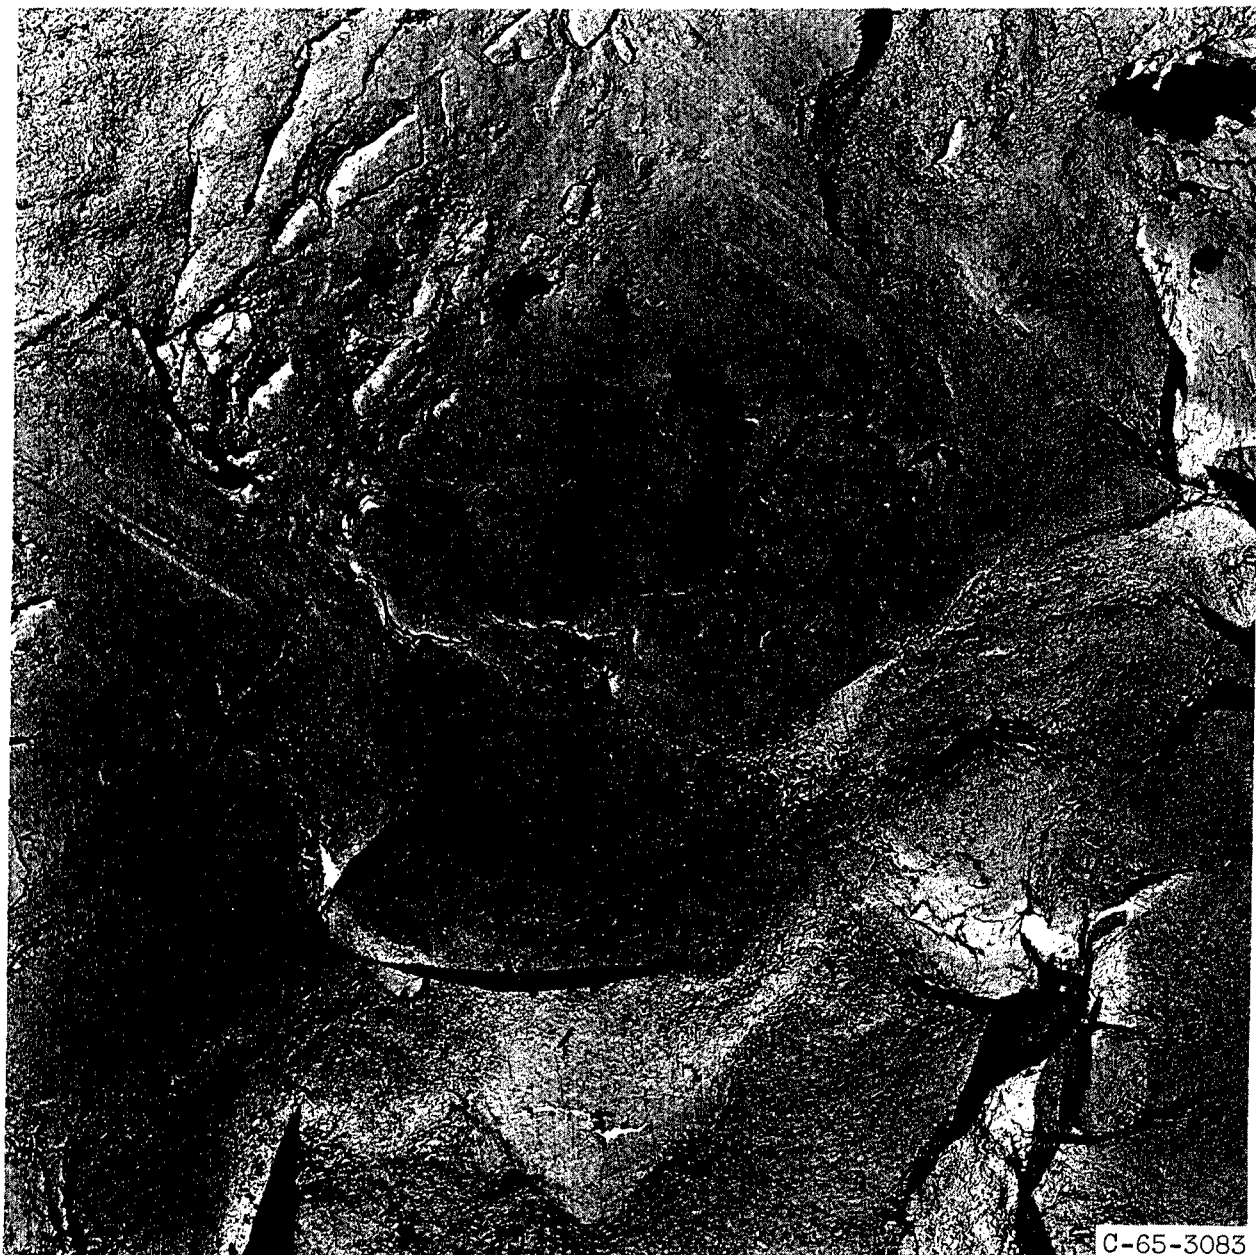
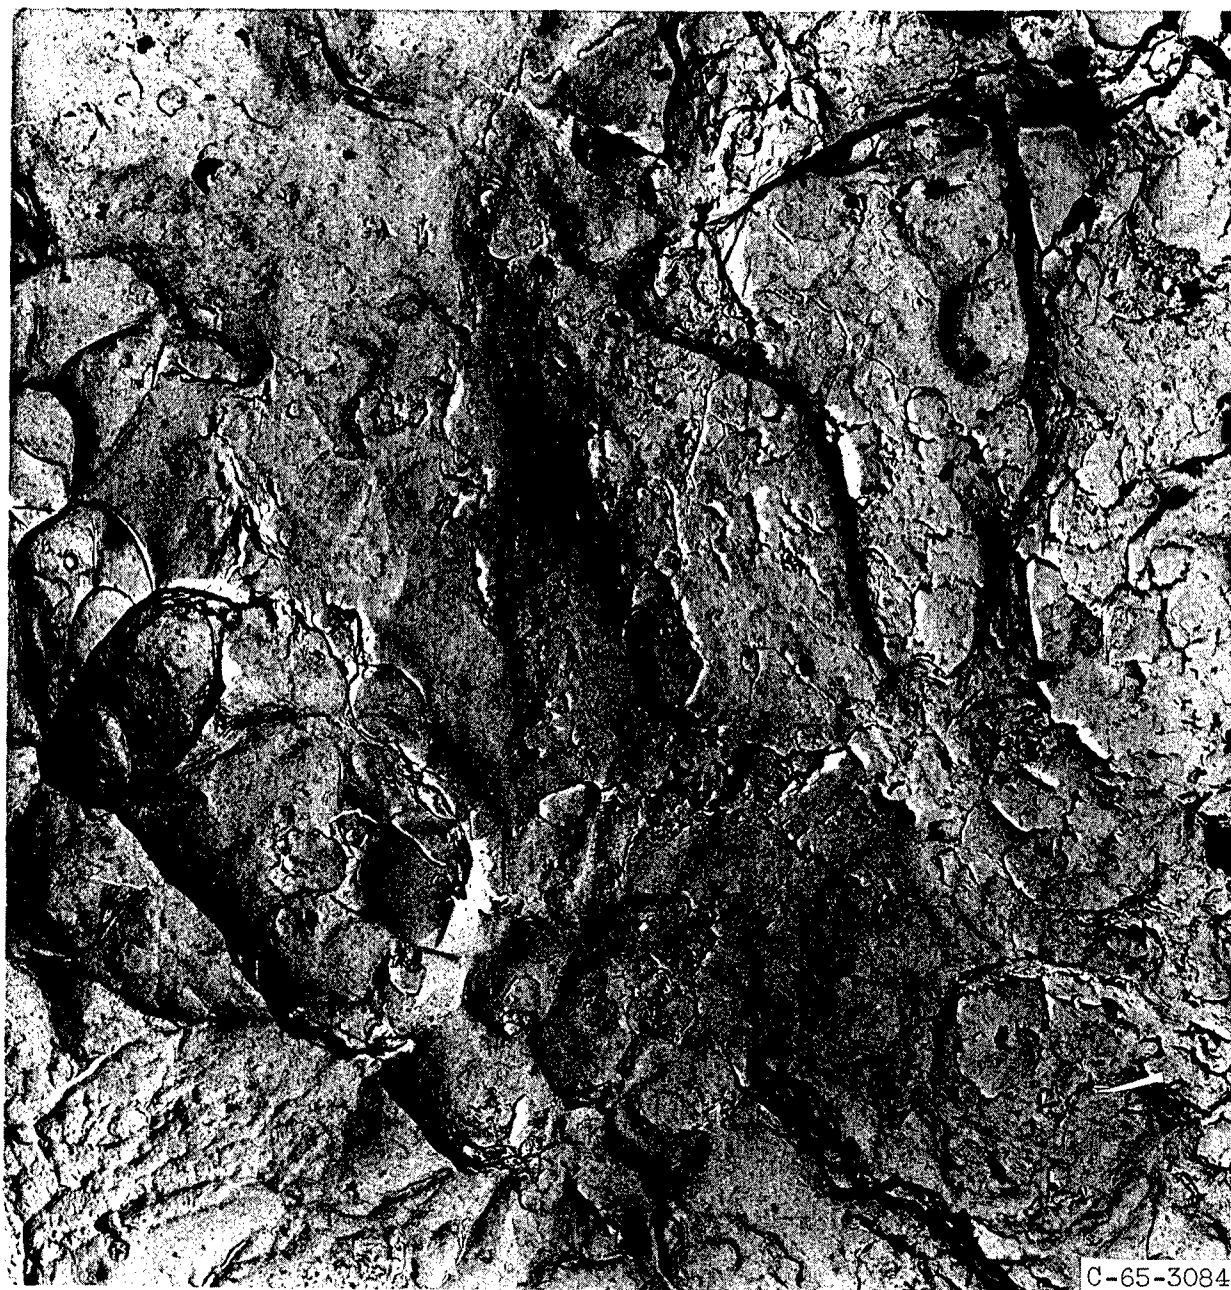
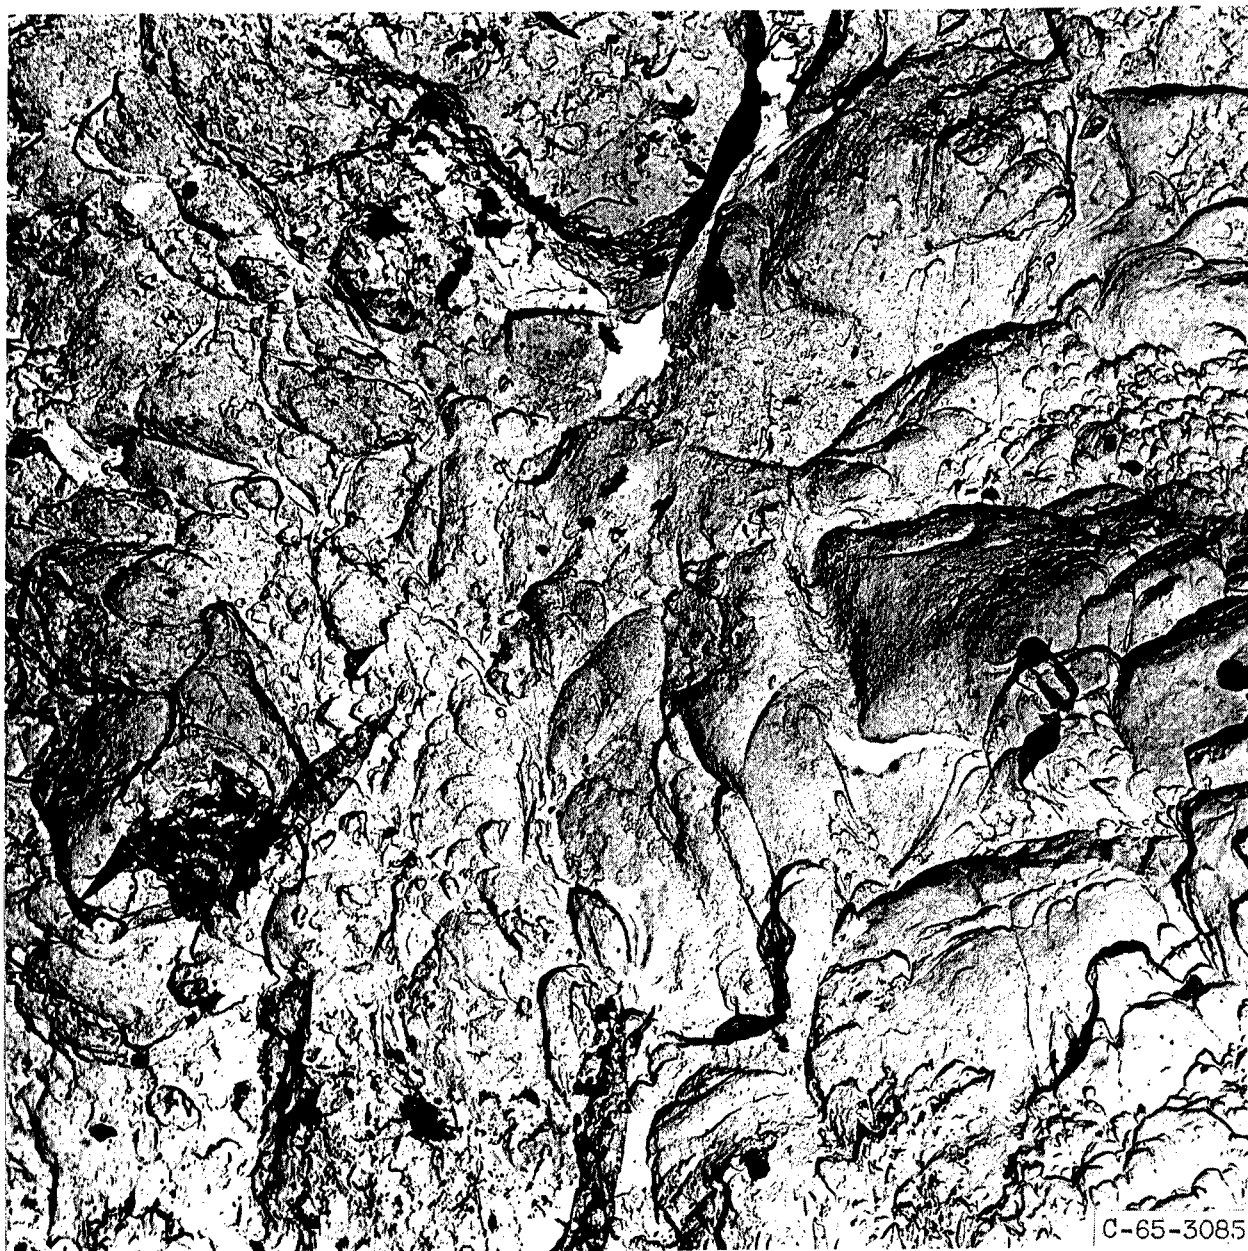
Figure 29. - Fractograph of black defect. x5000.

Fractographs of the black-defect surface taken in the various locations, identified as areas 1, 2, 3, 4, and 5 in figure 26, are shown in figure 29. Areas 1 to 3 are located within the black defect itself, and the fractographs (figs. 29(a) to (c)) show a generally flat, intergranular appearance. Various fine-scale surface features are visible in figures 29(a) to (c), but the presence of the black surface film prevents any detailed interpretation. Area 4 (fig. 29(d)), which lies in the subarc weld metal but outside the black defect, exhibits a somewhat more ductile appearance. Area 5 (fig. 29(e)), in a region of the fracture in the base plate outside the black defect, shows a distinctly dimpled contour indicative of ductile fracture.

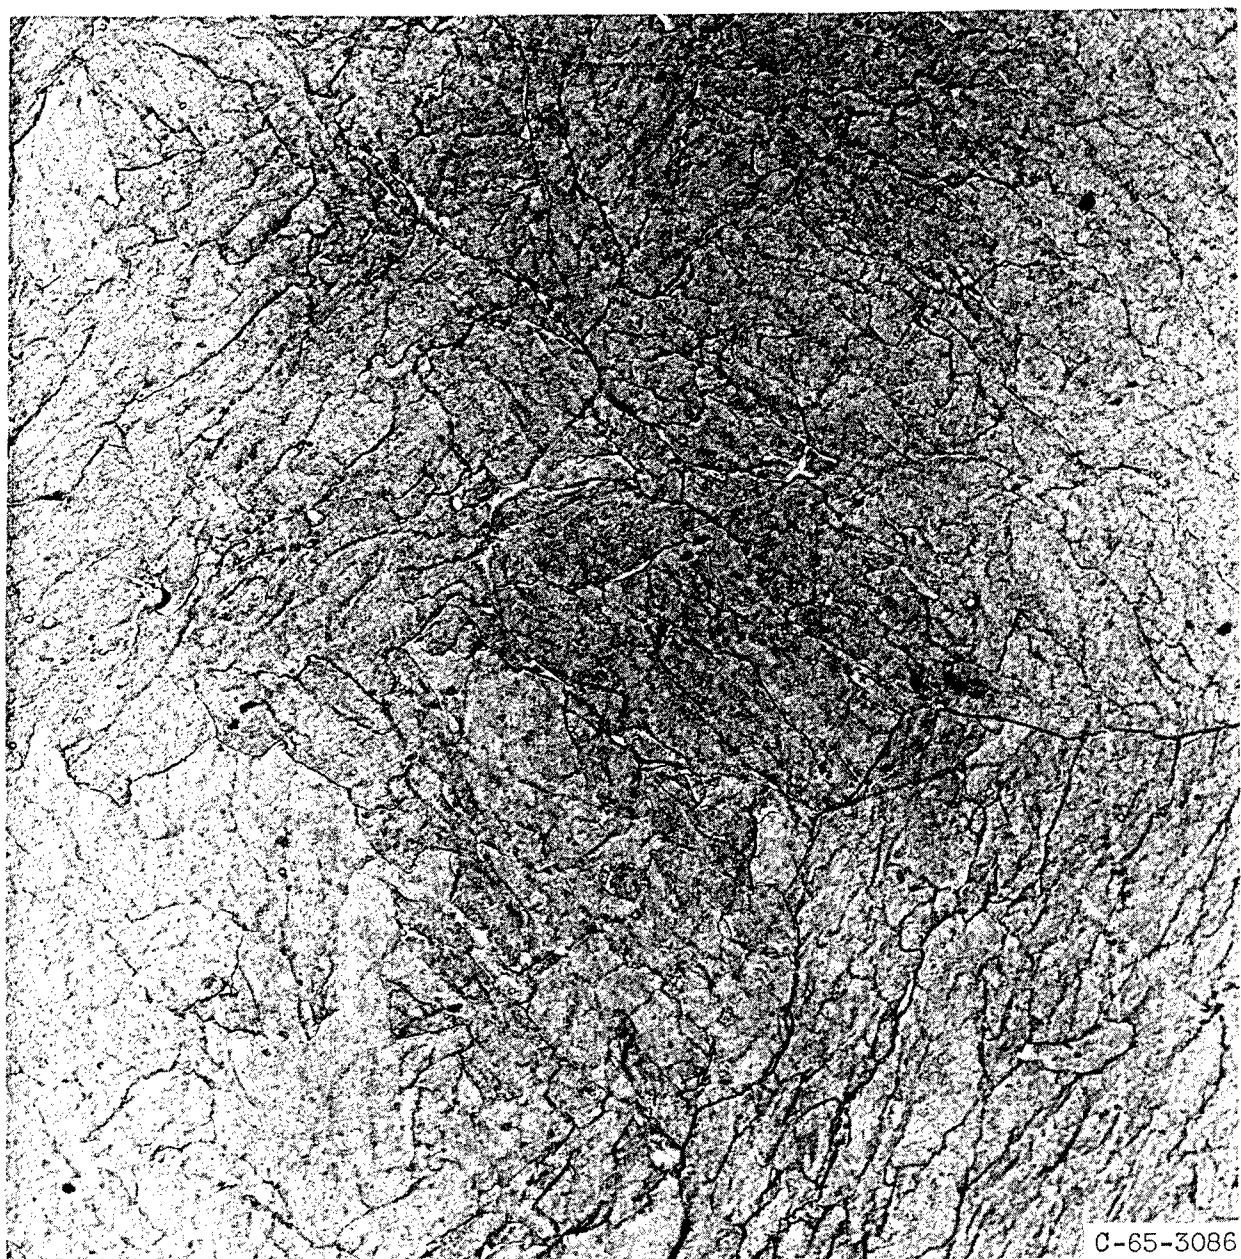
The HAZ of the base plate was examined at high magnification by replica microscopy; figure 30 shows typical areas near the black defect. The prior austenite boundaries - and to some extent, the martensite plate boundaries - show an enhanced etching characteristic and some evidence of second-phase particles, possibly austenite and/or TiC (ref. 6). These observations support the conclusion that the HAZ of the base plate experienced some embrittlement as a result of the thermal cycles that occurred during welding and weld repair.

Figure 30. - Replication electron micrograph of area near black defect (HAZ of base plate). x10 000.

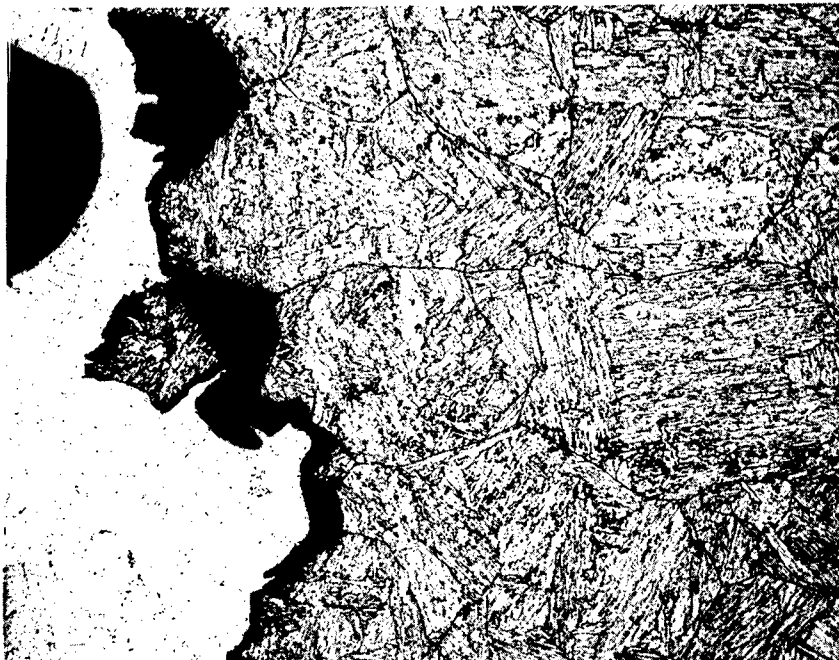
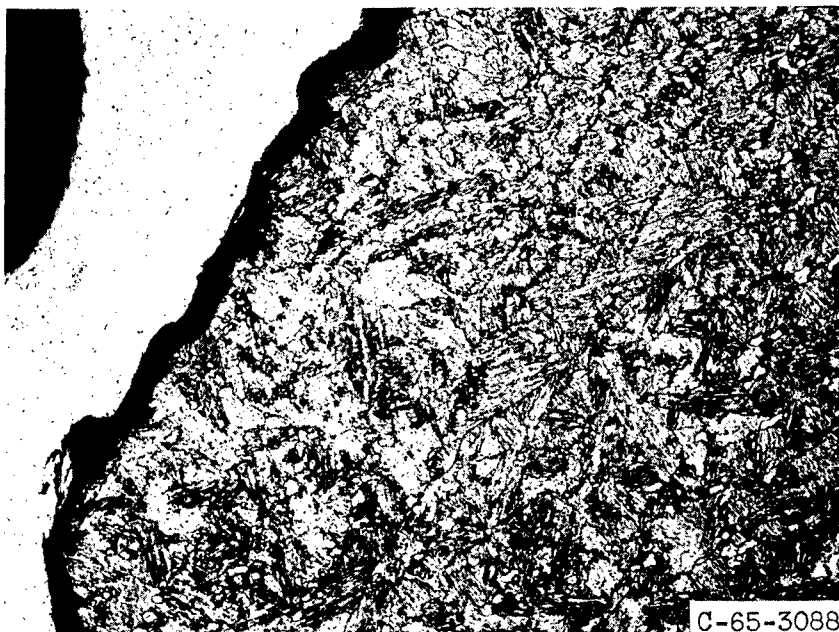
Figure 32. - Fracture profiles of fracture along weld
W7/302. x200.

Fracture profiles (fig. 32) show a typical path followed by the main fracture through the midthickness region of the weldment (fig. 32(a)) and near the weld surface (fig. 32(b)). It is interesting to note that the fracture in the midthickness region occurred entirely in the grain-coarsened zone, just outside the subarc weld metal. The unusual path taken by the fracture suggests that this region possessed perhaps the lowest fracture toughness in comparison with other regions of the weldment, and consisted of an embrittled microstructure.
